## Home Inspection Report

*Includes Complete Wood Destroying Organisms Inspection Report*  
*Washington State Department of Agriculture Inspection Control Number [REDACTED]*

[REDACTED]

9:15 am-2 pm  
February 19, 2009

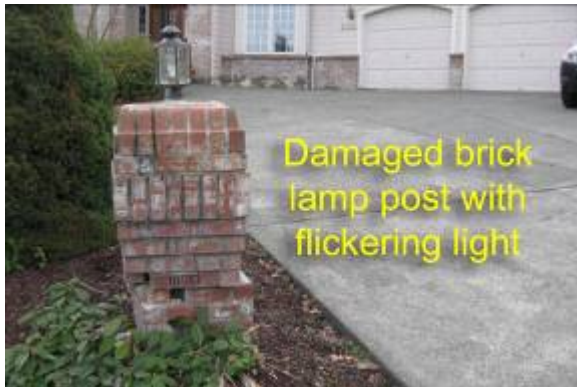
- **MAIN CONCERN** The brick lamp post at the end of the driveway is badly damaged (photo next page) and the lamp on top flickered on and off for no apparent reason during the inspection. The post needs to be rebuilt/repared and the wiring to the lamp checked and repaired as needed.

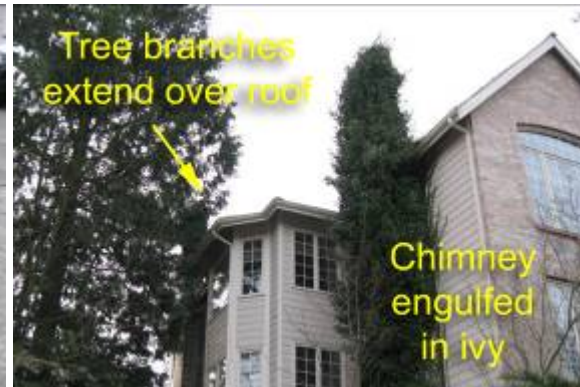
- Limbs from a large tree on the east side of the home extend over the roof (photo next page). Limbs and foliage can shade and promote moss and mildew growth on the roof and siding, clog gutters and provide access to the home for wood destroying organisms; tree roots can invade drainage systems and damage foundations. Ideally, the large tree should be removed; at a minimum it needs to be limbed up and pruned away from the home.

- Limbs from a large tree on the east side of the home extend over the roof. Limbs and foliage can shade and promote moss and mildew growth on the roof and siding, clog gutters and provide access to the home for wood destroying organisms; tree roots can invade drainage systems and damage foundations. Ideally, the large tree should be removed; at a minimum it needs to be limbed up and pruned away from the home.

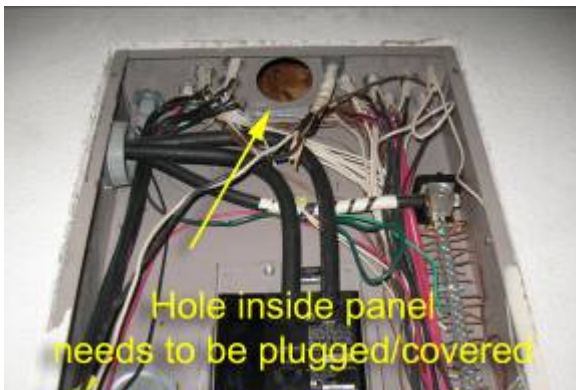
- There is a large uncovered knockout hole inside the main panel (photo next page); if rodents get into the wall, they can get inside the panel to damage wiring and cause short circuits (a real possibility). A knockout cover needs to be installed over the hole.

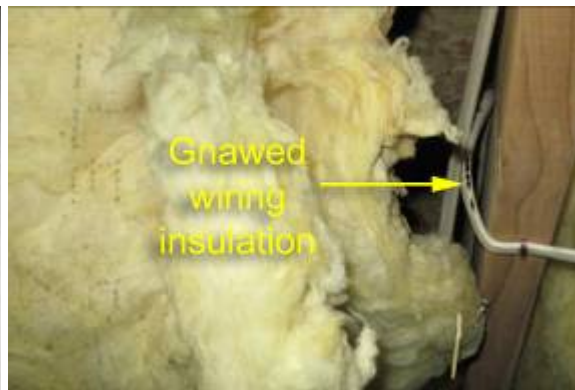
- Rodents have gnawed through the outer insulation on some of the wiring in the crawl space, a safety concern (photo next page); damaged wiring can arc to start fires, though properly functioning breakers normally trip before this occurs. Wiring in other areas of the crawl space should be inspected when rodent-damaged fiberglass insulation is replaced (as called for elsewhere in this report). If only the outer insulation of wiring is damaged and insulation around individual wires is intact, the wiring can be repaired by wrapping it with electrical tape; otherwise, some wiring may need to be replaced.

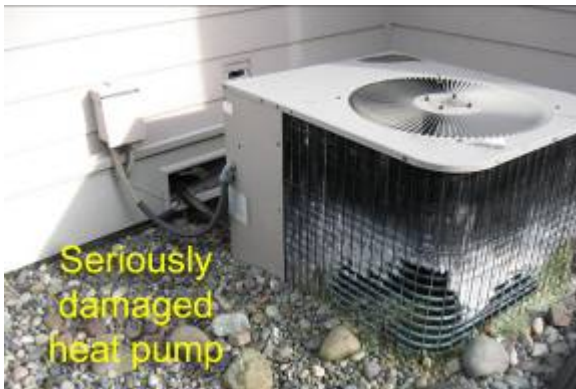
- **MAIN CONCERN** The heat pump is badly damaged and nonfunctional; it either needs to be replaced or removed.
- No heated air was detected at the register in the up common bath when the furnace operated. Lack of heated air at the register is probably not a serious problem, given the size of the room and circulation of heated air from the adjoining bedroom and hallway.
- Check the operation of the manually-operated gas fireplaces with the current owner to determine how they work and that they work properly.
