## Focused Home Inspection Report

*Includes Complete Wood Destroying Organisms Inspection Report*  
*Washington State Department of Agriculture Inspection Control Number [REDACTED]*

**Front View of Inspected Home  
(Front Faces North)**

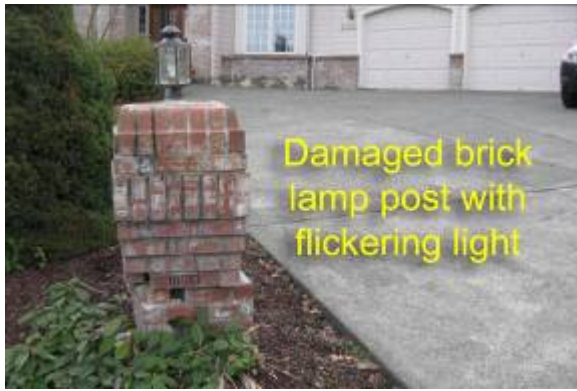
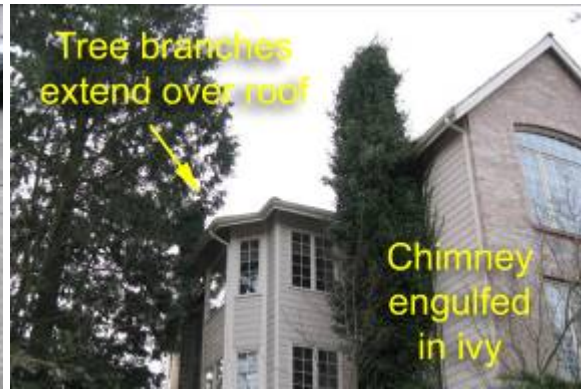
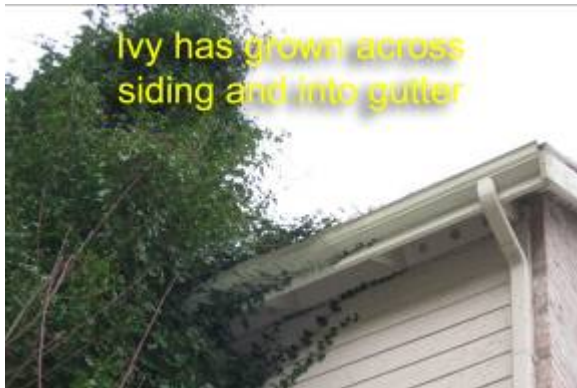
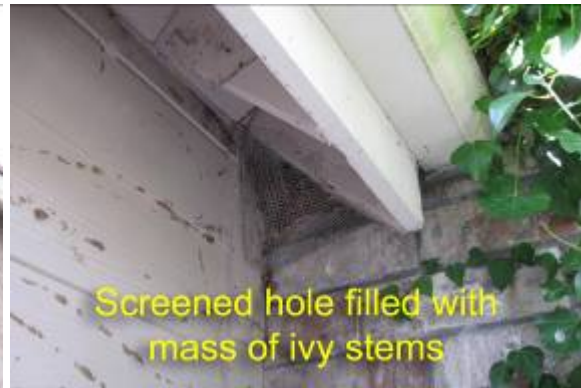
- **MAIN CONCERN** The brick lamp post at the end of the driveway is badly damaged (photo next page) and the lamp on top flickered on and off for no apparent reason during the inspection. The post needs to be rebuilt/repared and the wiring to the lamp checked and repaired as needed.

- **MAIN CONCERN** Ivy has engulfed the side chimney at the northeast corner of the home, grown across the siding and into the gutter on the north side of the chimney and under the fascia board and siding on the south side, creating a gap that has been covered with metal screening (photos next page). Plant foliage can clog gutters; clogged gutters overflow to rot wood structures below and create conditions conducive to other wood destroying organisms. When plant foliage “invades” to create gaps in siding and trim, it also provides access to the attic for unwanted critters; rodent droppings observed in that attic are testament to this fact. The ivy needs to be removed from the chimney, siding and gutter and the newly exposed areas inspected and repaired as needed.

- Limbs from a large tree on the east side of the home extend over the roof (photo next page). Limbs and foliage can shade and promote moss and mildew growth on the roof and siding, clog gutters and provide access to the home for wood destroying organisms; tree roots can invade drainage systems and damage foundations. Ideally, the large tree should be removed; at a minimum it needs to be limbed up and pruned away from the home.

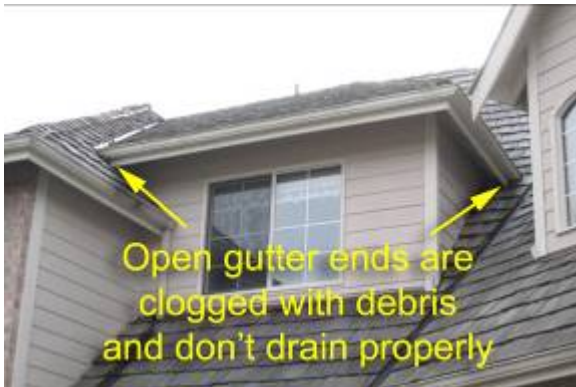
- The cedar shakes roof covering appears to be in good condition, but check with the current owner to determine when preservative was last applied to the shakes. If it has been more than five years, the shakes need to be treated; regular application of preservative maximizes the life of a cedar shake roof.
- The open gutter ends on the dormer above the front entry, like the ivy-filled gutter previously described, are clogged with debris; other gutters may be clogged, too (observation of the gutters was limited due to the height of the roof). Clogged gutters overflow to create conditions conducive to rot and other wood destroying organisms. All the gutters need to be inspected and cleaned as needed.
- The chimney flues lack weather caps to prevent rain from entering the chimney and combining with combustion gases to deteriorate bricks and mortar. Weather caps need to be installed.

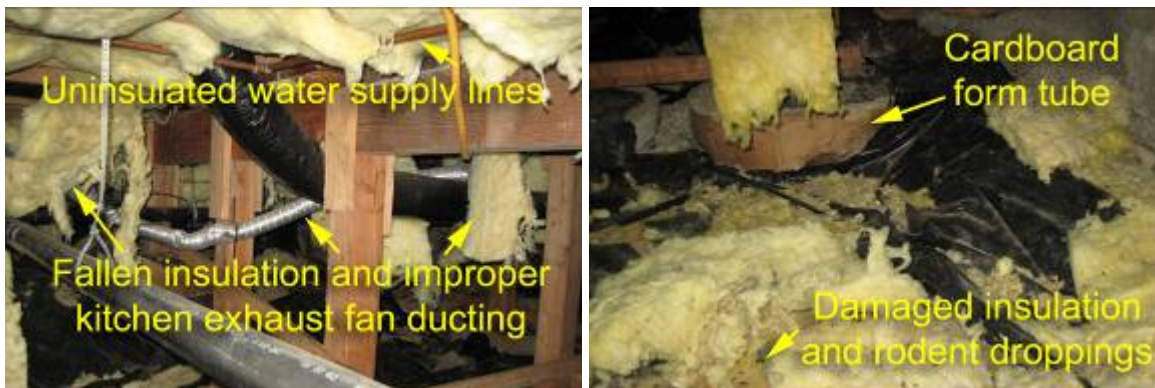
- Some of the insulation between the floor joists in the crawl space has fallen and needs to be re-installed; some of the insulation has been damaged by rodents and needs to be replaced. (Once the damaged crawl space vent screen previously mentioned is repaired/replaced, the rodent problems should disappear.)

- Flexible metal ducting for the gas cook top exhaust fan sags, allowing moisture to collect in the ducting; the ducting needs to be properly secured so sagging is minimized.

- Cardboard form tubes remain in place around the poured concrete footings in the crawl space; cardboard in contact with the soil can attract wood destroying organisms. Ideally, the cardboard form tubes should be removed to the soil line.

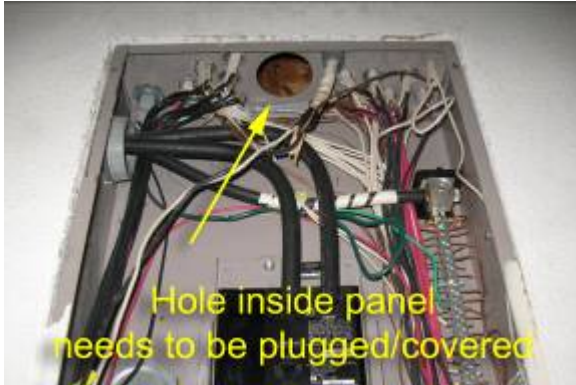
- There is a large uncovered knockout hole inside the main panel (photo next page); if rodents get into the wall, they can get inside the panel to damage wiring and cause short circuits (a real possibility). A knockout cover needs to be installed over the hole.

- Rodents have gnawed through the outer insulation on some of the wiring in the crawl space, a safety concern (photo next page); damaged wiring can arc to start fires, though properly functioning breakers normally trip before this occurs. Wiring in other areas of the crawl space should be inspected when rodent-damaged fiberglass insulation is replaced (as called for elsewhere in this report). If only the outer insulation of wiring is damaged and insulation around individual wires is intact, the wiring can be repaired by wrapping it with electrical tape; otherwise, some wiring may need to be replaced.

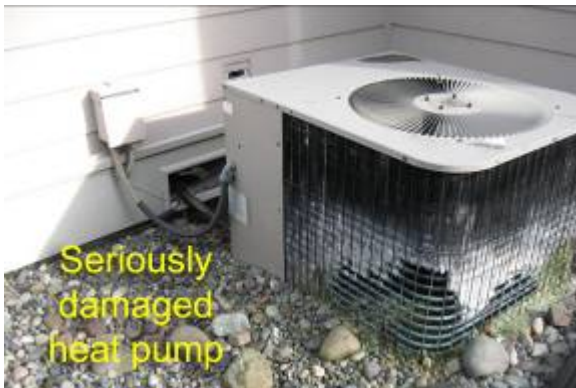
- **MAIN CONCERN** The heat pump is badly damaged and nonfunctional; it either needs to be replaced or removed.
- No heated air was detected at the register in the up common bath when the furnace operated. Lack of heated air at the register is probably not a serious problem, given the size of the room and circulation of heated air from the adjoining bedroom and hallway.
- Check the operation of the manually-operated gas fireplaces with the current owner to determine how they work and that they work properly.
