## Home Inspection Report

*Includes Complete Wood Destroying Organisms Inspection Report*  
*Washington State Department of Agriculture Inspection Control Number [REDACTED]*

[REDACTED]

9:15 am-2 pm  
February 19, 2009

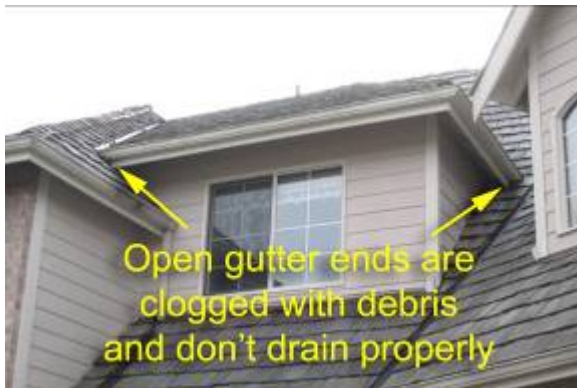
- The cedar shakes appear to be in good condition, but check with the current owner to determine when preservative was last applied to the roof. If it has been more than five years, the shakes need to be treated; regular application of preservative maximizes the life of a cedar shake roof.
- The open gutter ends on the dormer above the front entry, like the ivy-filled gutter previously described, are clogged with debris; other gutters may be clogged, too (observation of the gutters was limited due to the height of the roof). Clogged gutters overflow to create conditions conducive to rot and other wood destroying organisms. All the gutters need to be inspected and cleaned as needed.
- The chimney flues lack weather caps to prevent rain from entering the chimney and combining with combustion gases to deteriorate bricks and mortar. Weather caps need to be installed.

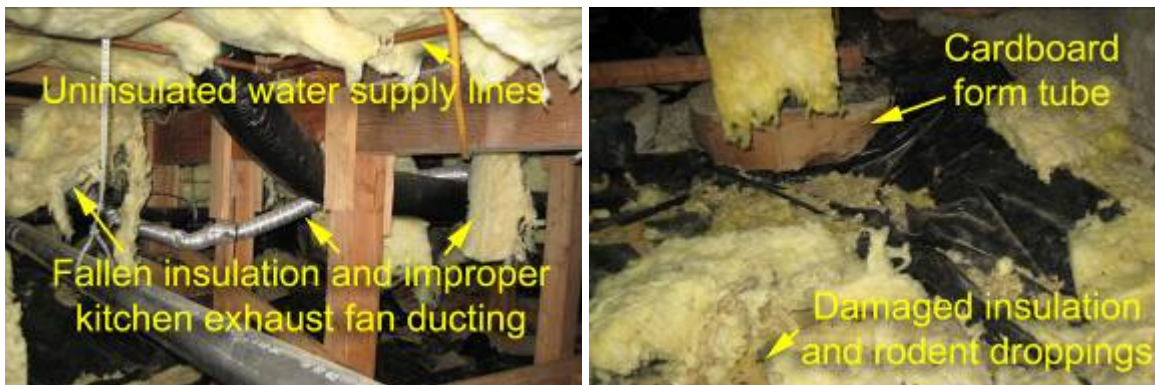
- Flexible metal ducting for the gas cook top exhaust fan sags, allowing moisture to collect in the ducting; the ducting needs to be properly secured so sagging is minimized.

- Cardboard form tubes remain in place around the poured concrete footings in the crawl space; cardboard in contact with the soil can attract wood destroying organisms. Ideally, the cardboard form tubes should be removed to the soil line.
